TWR - 17272, Vol. VI

FLIGHT SET 360L001 (STS-26) IGNITER,  
POST FLIGHT, FINAL REPORT

5 APRIL 1990

FLIGHT SET 360L001 (STS-26)  
IGNITER FINAL REPORT VOLUME VI

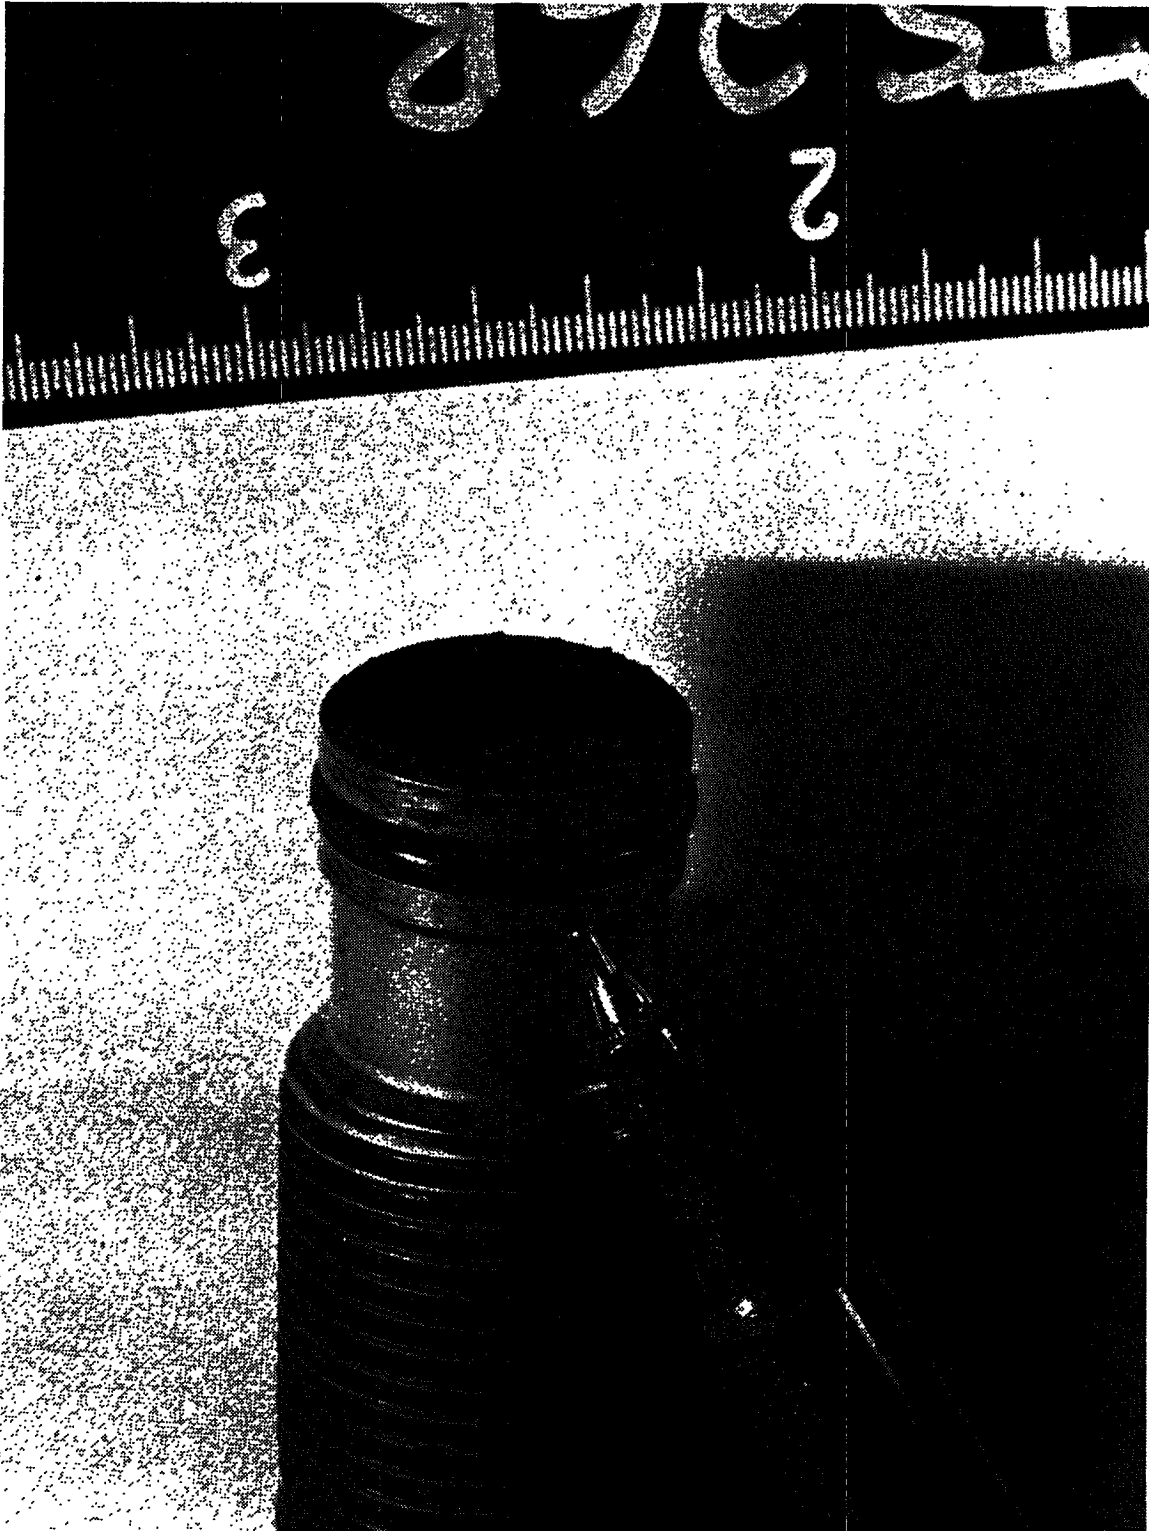
All eight special bolts showed no signs of heating or blowby past the seals. No signs of physical damage to the seals, bolt or igniter chamber area. Corrosion was observed on the bottom of all 8 special bolts (figure 13). This corrosion came from the igniter chamber. The bolts are made of corrosion resistant steel. This corrosion in the chamber is below the sealing surface area. None

of the corrosion seen will affect the bolts or bolt chambers ability for refurbishment. The corrosion is caused by combustion products and by salt water which is forced up the transducer pressure ports during splash down. This has been seen in the past.

Figure 13. Special Bolt Corrosion

All special bolts performed as predicted. RSRM 5 and subsequent flights will have added grease in this area to prevent corrosion.

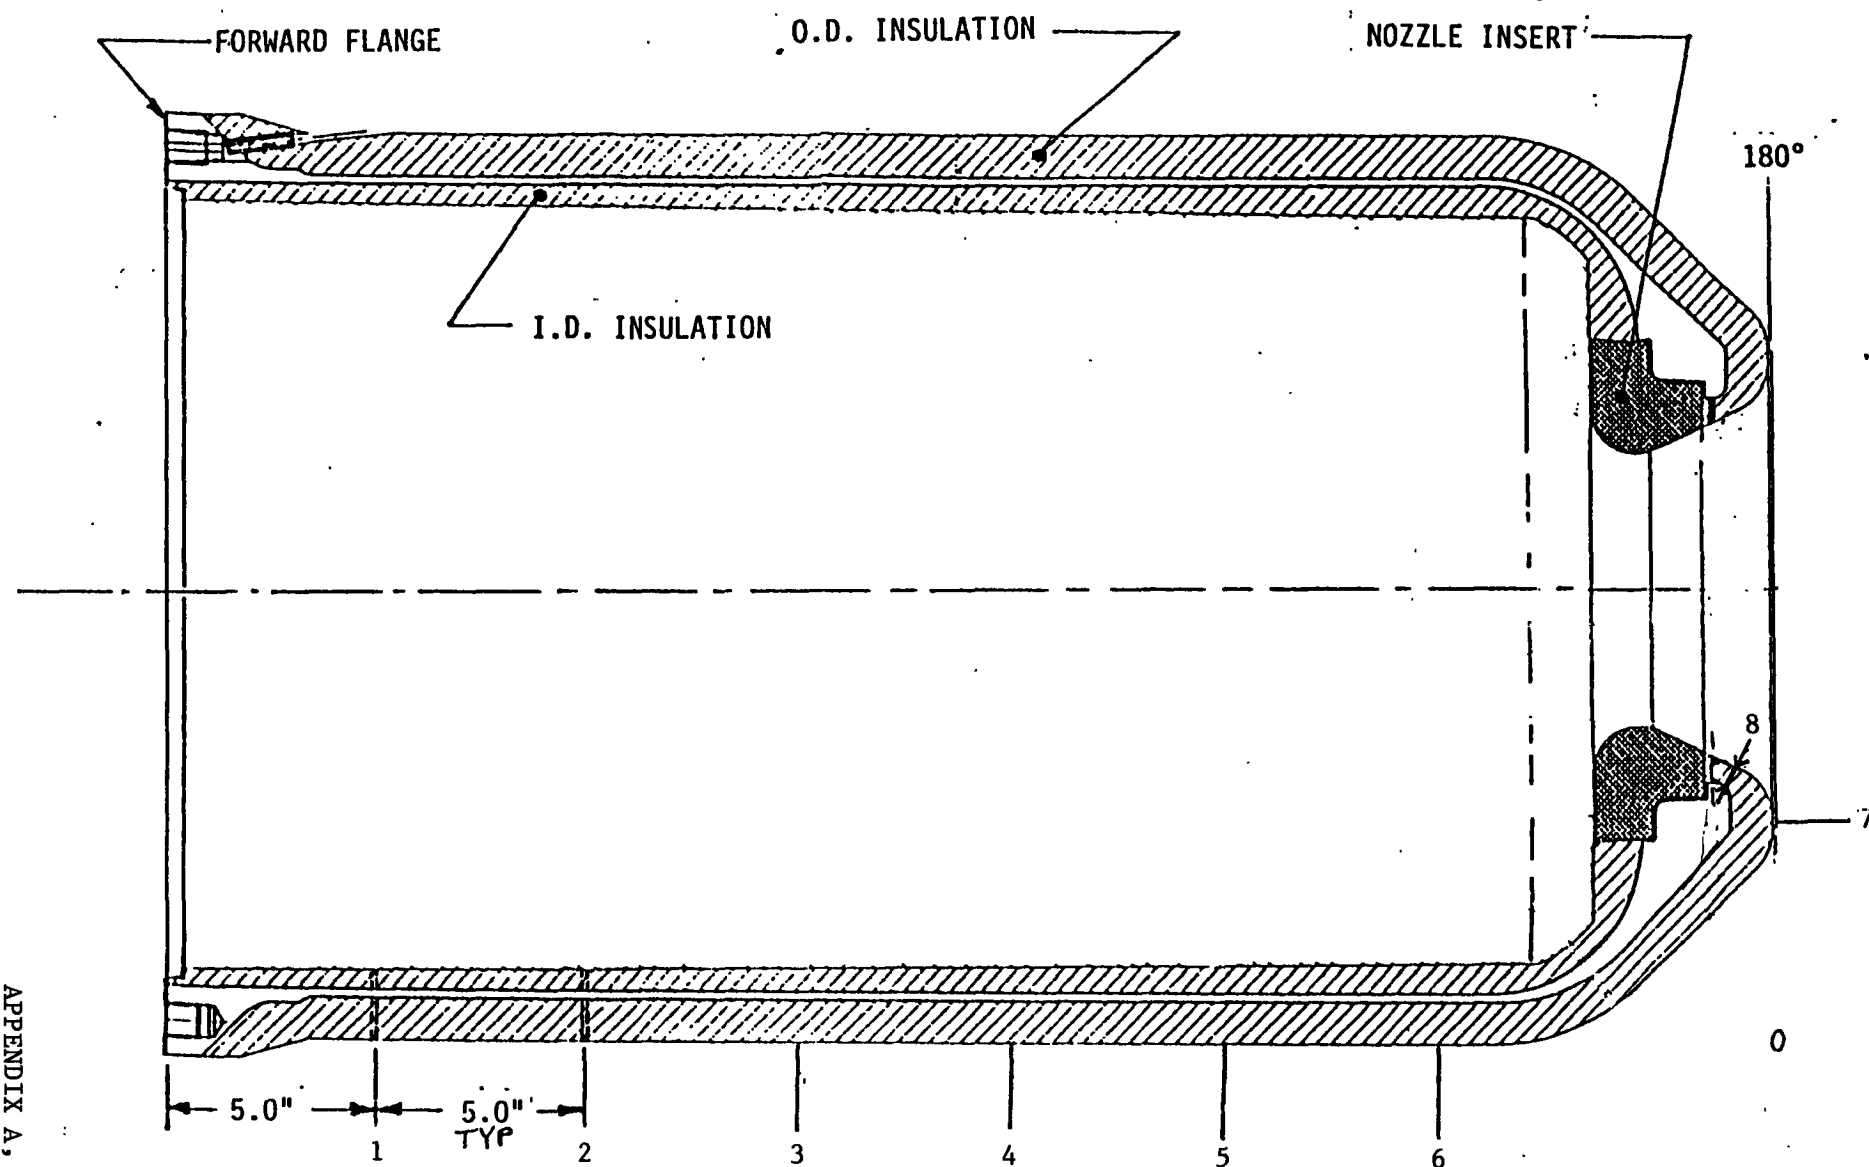
FIGURE A1

The areas of the insulation which have the most heat affects were measured for thickness prior to flight and after flight. Figure A1 shows the location of the thickness measurements. Table AI, Insulation Thickness History, shows a summary of insulation char depth for all igniters tested in the RSRM program. Location #8 sees char depth that exceed the 1.5 required safety factor. This area of excessive charring is not a concern for safety. Waver # RVW579 R1 has been submitted and approved by NASA for this area only. Visual inspection of all RSRM igniter shows no excessive heating in this area. (Pages B7 and B8 of Appendix B)

Post Test Plug Positioning For Insulation Measurements
